TESS-W maintenance notes

by Jaime Zamorano, Cristóbal García, Rafael González and Lucía García
2020/12/31 version 2 (for distribution to customers)

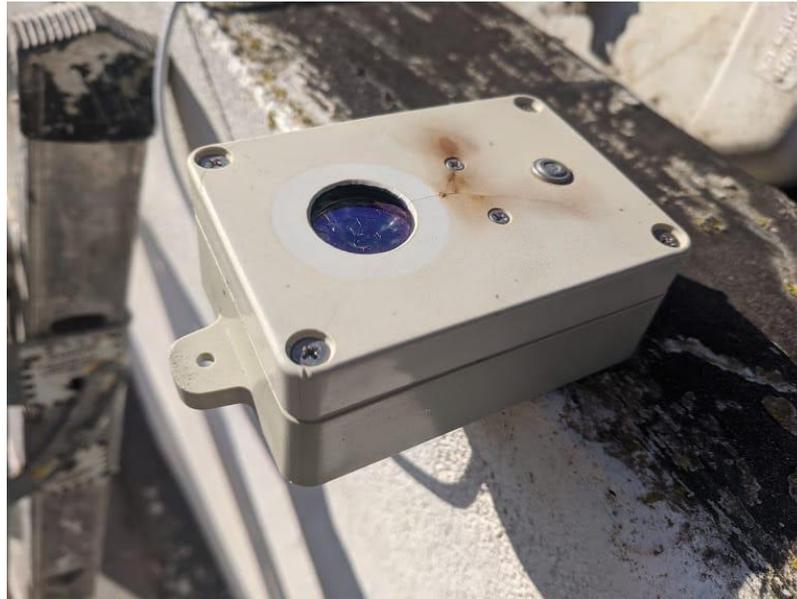
Unfortunately, this faulty can only be detected after outdoor exposure during some time. While the first TESS-W units (including the prototypes) have been resisting the weather for 6 years, other photometers show defects in the enclosure after a time. Some photometers as stars273 are showing a crack on the box top from the window to the IR sensor.

Figure 1. TESS-W stars273 in Malta showing a significant crack on the box top and loss of the window.

- a) Visually inspection of your photometer.
In case that some defects are detected, please send us a picture.
- b) Strengthen the cover of the boxes of these photometers by adding an aluminum foil sheet (read below).
- c) Clean the IR sensor.
This sensor has no glass window and the rain is not enough to clean the entrance.

An easy and strong protection for already installed photometers which are in good condition is an adhesive aluminum tape of 75 mm width. It is easier to find adhesive aluminum tape of 50 mm width. You can also use it. It is important not to cover the entire box. The aluminum should not cover the bottom of the box to allow the wifi connection. We expect some loss of wifi signal. The next images show the system in different steps of setting in place. Please ask us for a precut tape if you need it.

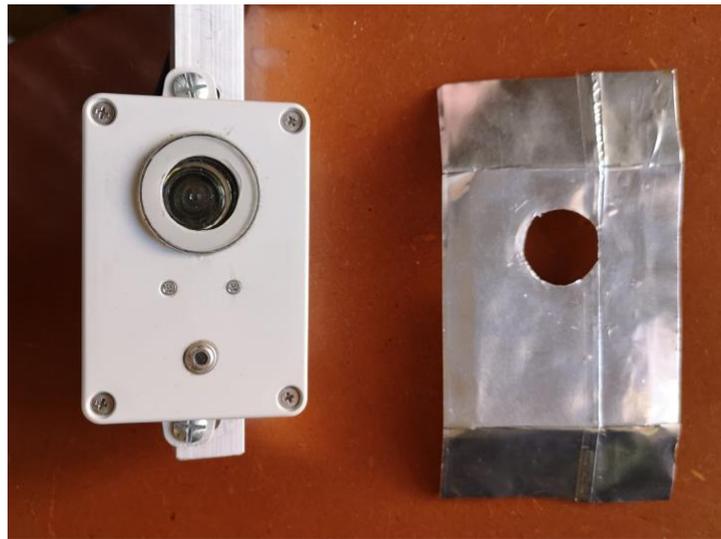
Figure 2. TESS-W photometer and the aluminum tape before placing on top of the cover.

The circular opening for the window should be larger than the light entrance and partially cover the glass window to extra fastening of the glass window.

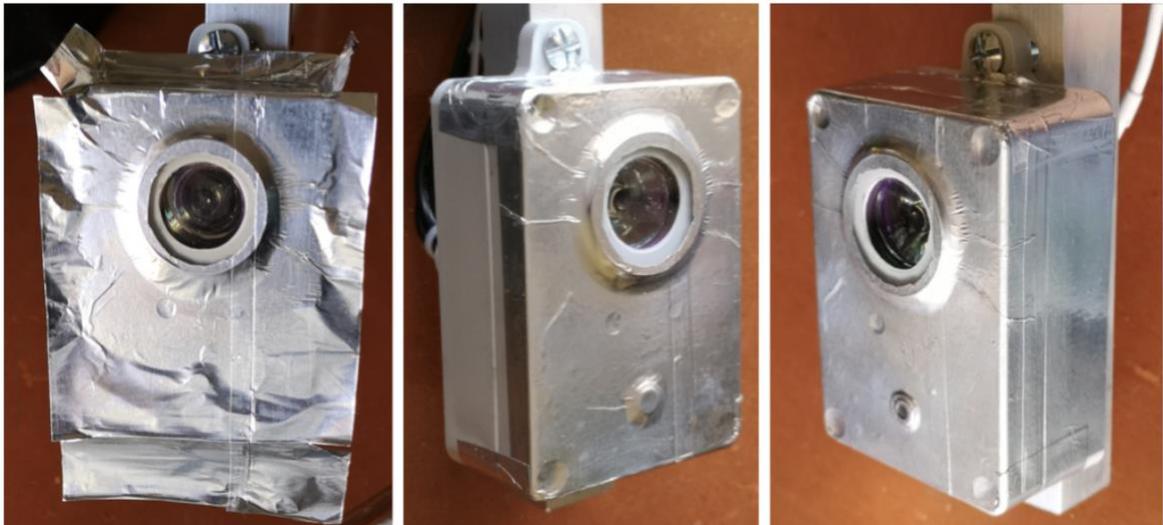
Figure 3. Different steps of the process and final result.

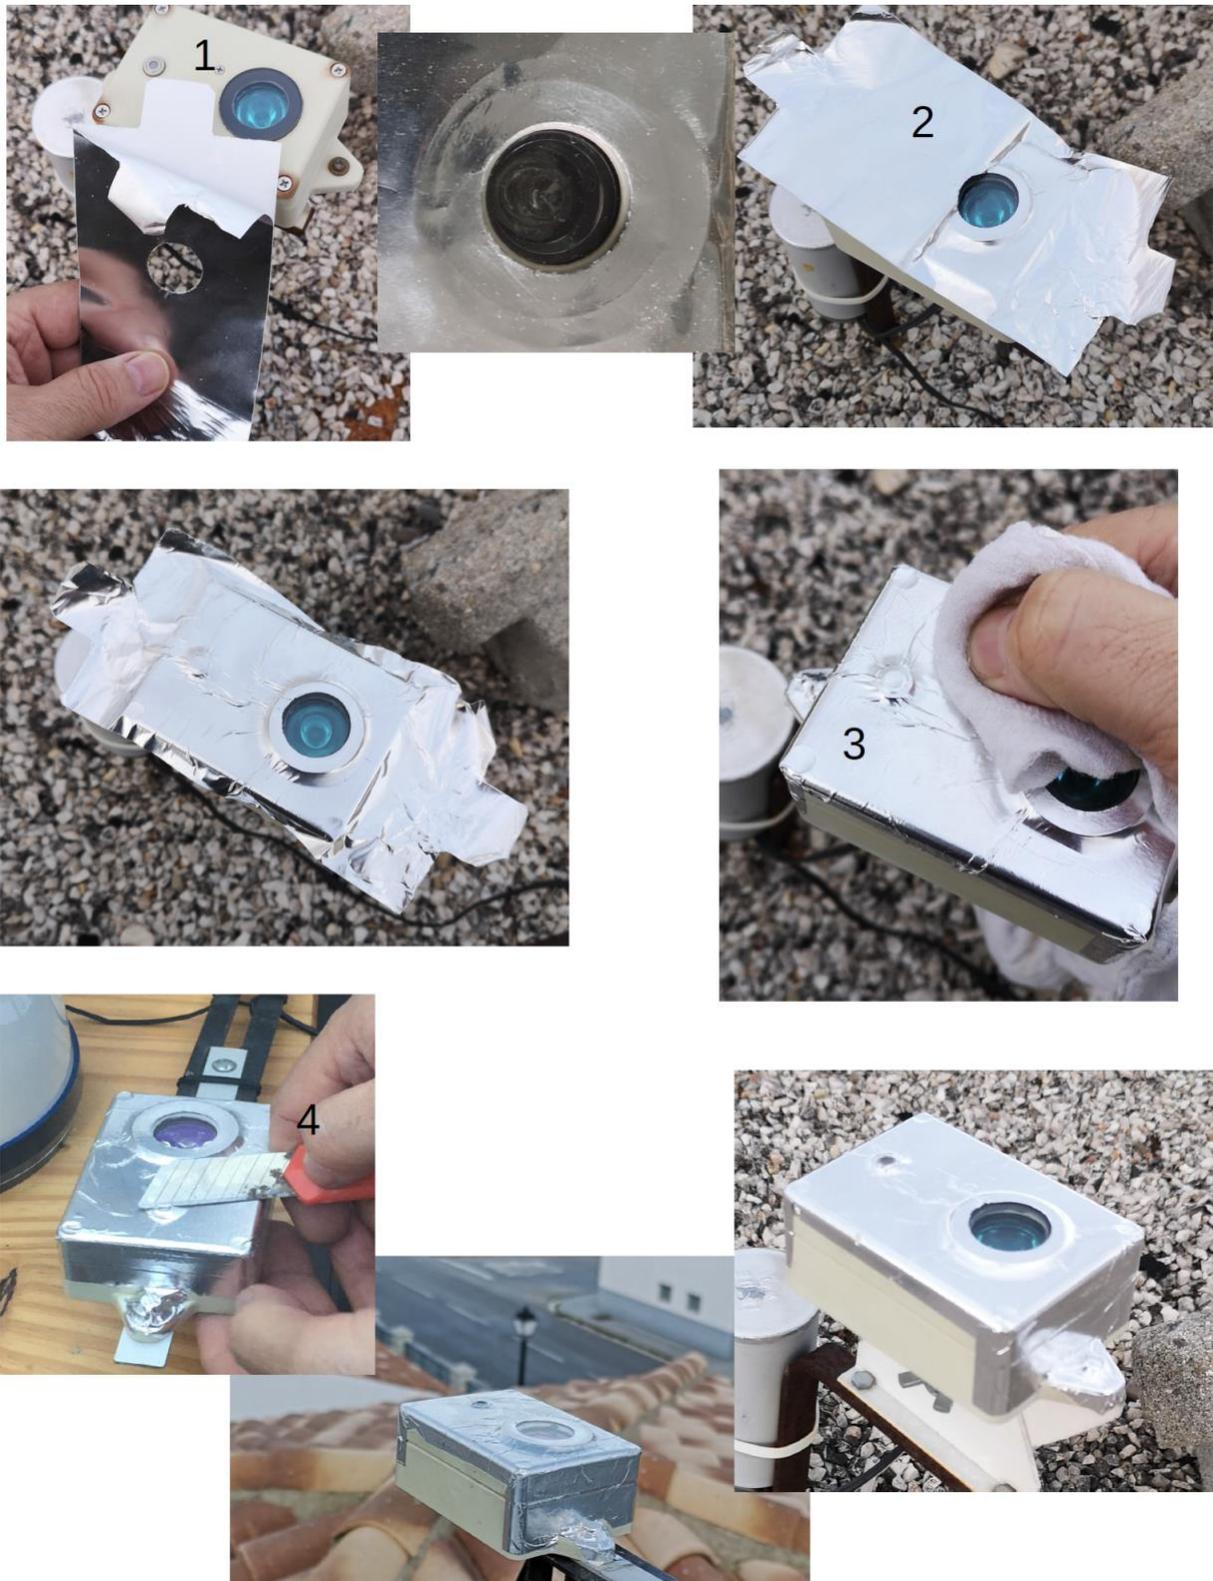
Figure 4. More pictures of the process.
